**TEST RESULTS**

**TENSILE TEST RESULTS**

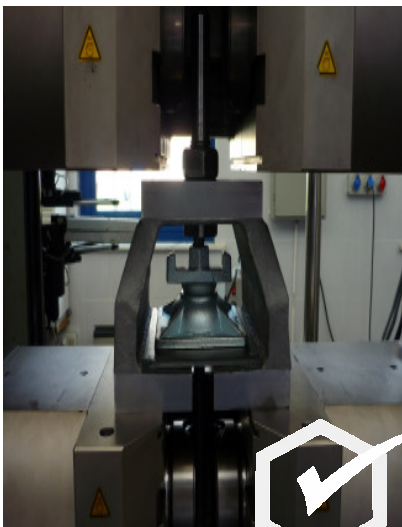
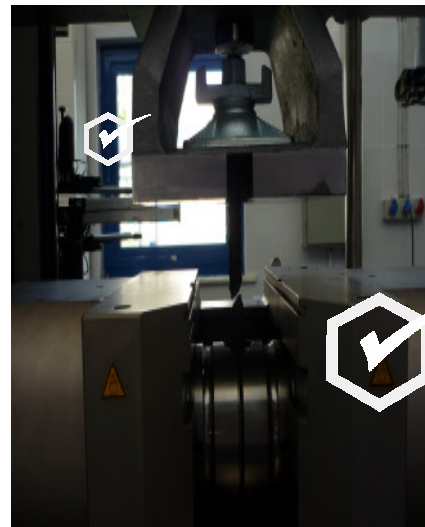
<b>TEST DEVICE</b>	<b>INFORMATION ABOUT TEST</b>
Name : Universal Testing Machine	Sample Preparation : Ready
Brand : INSTRON	Date of Test : 11.11.2014
Article No : 253030605080713	Applied Method : Tensile-10mm/min
Device Type : Digital	Ambient Temperature : 21 C

Sample photos of test arrangement are given below.

<b>SAMPLE</b>	<b>MEASURED LOAD (kN)</b>	<b>REMARKS/RESULTS</b>
SLOPE NUT 120X120 (Ø32 HOLE)	208,75	After applying tensile force on sample till the value of 208,75 kN, it is seen that the tie rod was broken at this force and there was not any deformation on the cast.
SLOPE NUT 120X120 (50mm DISTANCE)	207,71	After applying tensile force on sample till the value of 207,71 kN, it is seen that the tie rod was broken at this force and there was not any deformation on the cast.
SLOPE NUT 140X140 (Ø32 HOLE)	209,09	After applying tensile force on sample till the value of 209,09 kN, it is seen that the tie rod was broken at this force and there was not any deformation on the cast.
SLOPE NUT 140X140 (50mm DISTANCE)	209,18	After applying tensile force on sample till the value of 209,18 kN, it is seen that the tie rod was broken at this force and there was not any deformation on the cast.
TIE ROD NUT 70mm (Ø32 HOLE)	201,21	After applying tensile force on sample till the value of 201,21 kN, it is seen that stripping occurred at this force and there was not any deformation on the cast.

TIE ROD NUT 90mm (Ø32 HOLE)	204,88	After applying tensile force on sample till the value of 204,88 kN, it is seen that stripping occurred at this force and there was not any deformation on the cast.
TIE ROD NUT 100mm (Ø32 HOLE)	208,65	After applying tensile force on sample till the value of 208,65 kN, it is seen that the tie rod was broken at this force and there was not any deformation on the cast.
TIE ROD NUT 100mm (50mm DISTANCE)	184,48	After applying tensile force on sample till the value of 184,48 kN, it is seen that stripping occurred at this force and there was not any deformation on the cast.
SLOPE NUT Ø120 (Ø32 HOLE)	209,00	After applying tensile force on sample till the value of 209,00 kN, it is seen that the tie rod was broken at this force and there was not any deformation on the cast.
SLOPE NUT Ø120 (50mm DISTANCE)	207,49	After applying tensile force on sample till the value of 207,49 kN, it is seen that the tie rod was broken at this force and there was not any deformation on the cast.
